No.110

Oversize cutting of internal threads

Cutting
tap

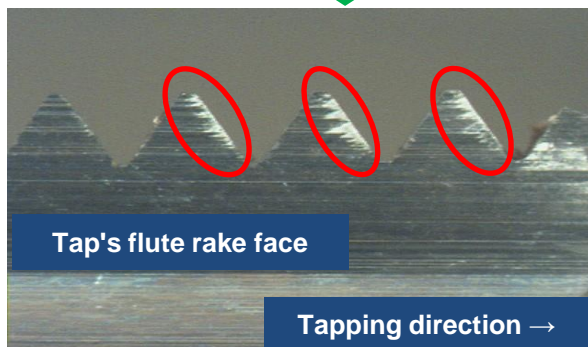
● Over feeding

When the tap proceeds with more than one lead of the thread by one rotation, abnormal cutting marks appear on the leading flanks. This over cutting results in oversize of the internal thread.

- * Adjust the weight balance of the main spindle.
- * In case of "over feeding", strengthen the tension spring.
- * In case of "under feeding", strengthen the compression spring.

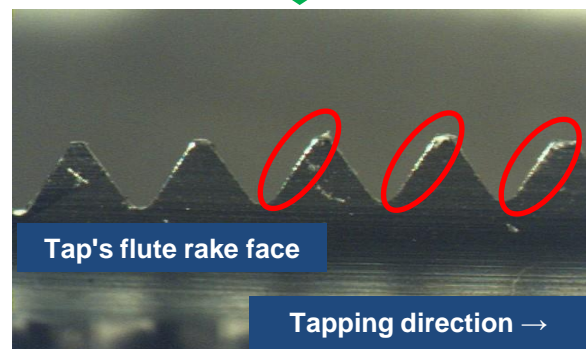
● Under feeding

When the tap proceeds with less than one lead of the thread by one rotation, abnormal cutting marks appear on the following flanks. This over cutting results in oversize of the internal thread.
