I would like to continue using my worn taps by resharpener them. Can you tell me the critical points I have to keep in mind when regrinding my used taps.

Surface areas available for regrinding used taps and issues of concern.

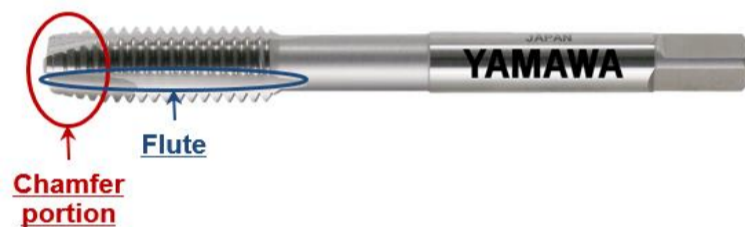
Example: Hand Taps. The surface areas available for regrinding a worn tap are the chamfer angle and the inside of each flute.

When taps are reground, it is essential to maintain the same chamfer angle to recreate an identical cutting performance to that of a new tap. Regrinding the chamfer extends its length from ① to length ② as shown above. The extra length of the chamfer is normally acceptable in tapping through holes but the front end of the resharpener tap will likely hit the bottom of the hole when tapping blind holes. Recreating the taps chamfer original length by cutting off the front end of the tap may be necessary but it will increase the grinding time and increase resharpener costs.

The chamfer relief is ground in a tangent curve to the outside diameter of the tap. The chamfer relief is not in a simple circular arc that is concentric to the diameter of the tap. The indicator drop for the chamfer relief ③ shown above changes depending on the tap type. It is difficult to select the indicator drop without proper instructions and reference

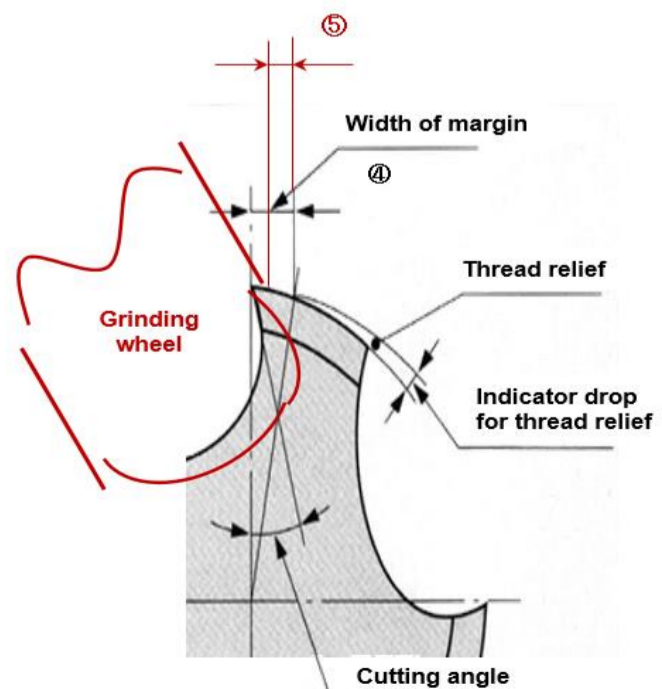
When regrinding inside the flutes, it is mandatory to maintain the same cutting angle of the original tap to recreate an identical cutting performance to that of a new tap. Regrinding inside the flutes will result in decreasing the width of the circular margin from ④ to ⑤ as shown at the right. This can cause an unstable tapping performance.
